Post-Event Evaluation of Natural Gas Pipeline System After Hurricane Sandy

Khalid Farrag, Ph.D., PE, PMP
Gas Technology Institute

Jie Gong, Ph.D.
Department of Civil and Environmental Engineering
Rutgers, The State University of New Jersey

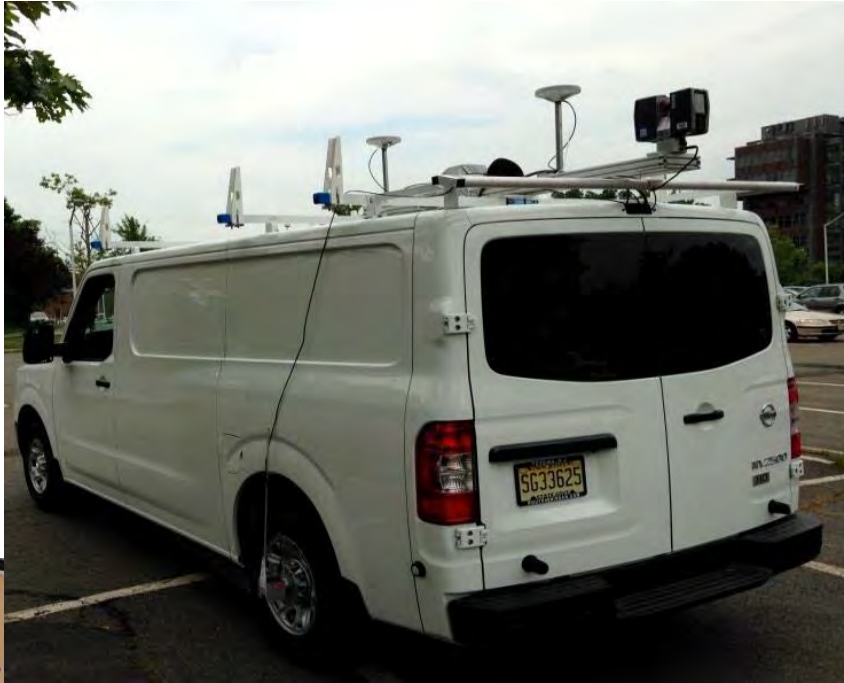
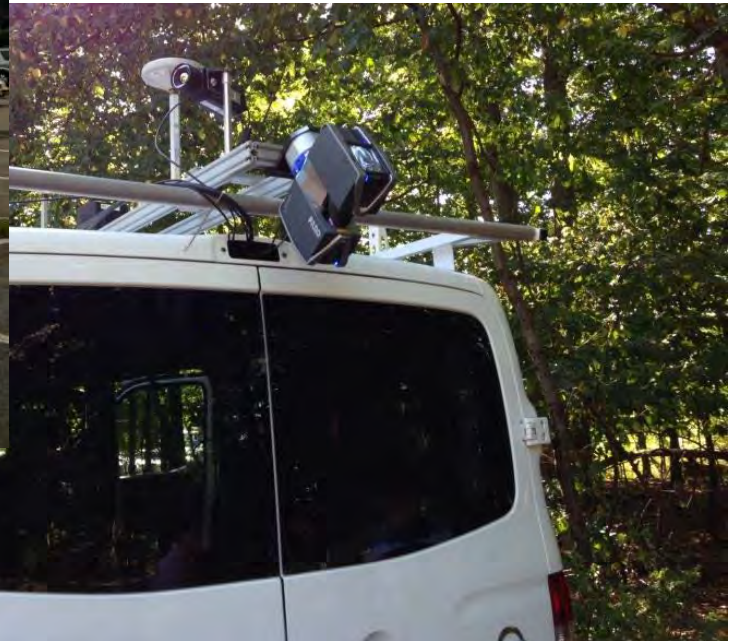
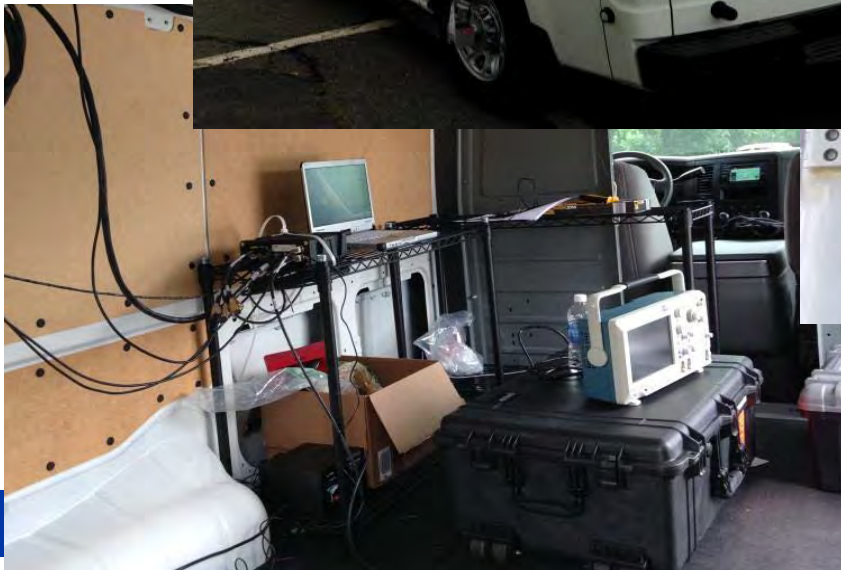
Rutgers Integrated Mobile LiDAR System

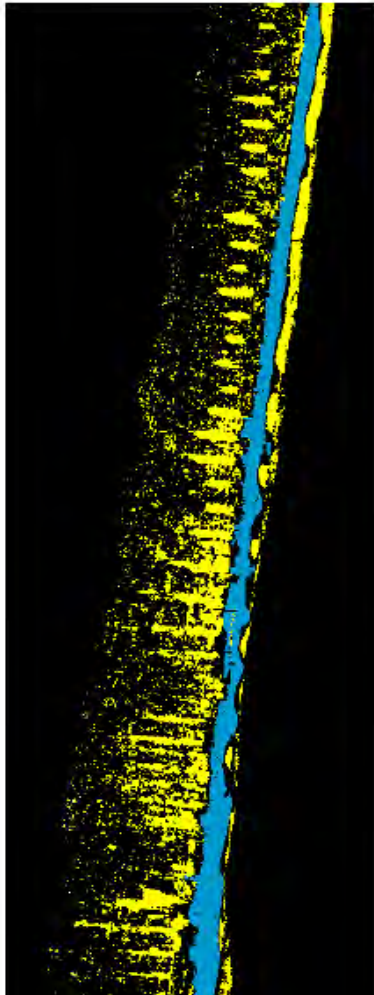
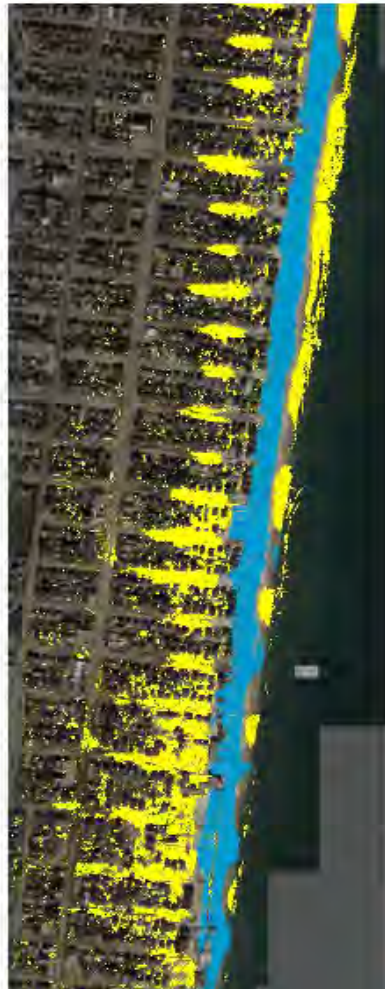
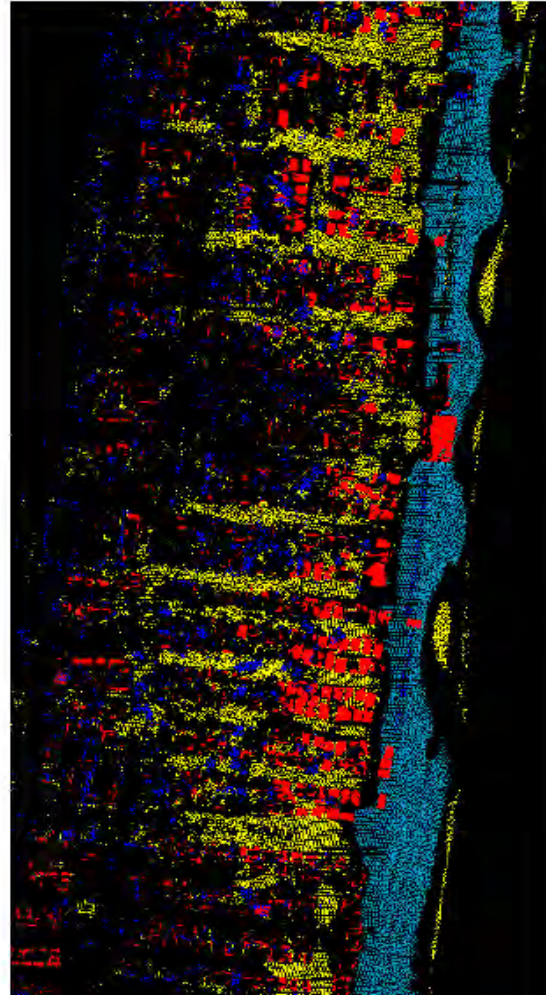
Debris Field and Flow at Ortley Beach

- **Yellow:**
Sand Debris
- **Cyan:** Erode
Dunes
- **Red:**
Destroyed
Buildings
- **Blue:**
Building
Debris or
Changes

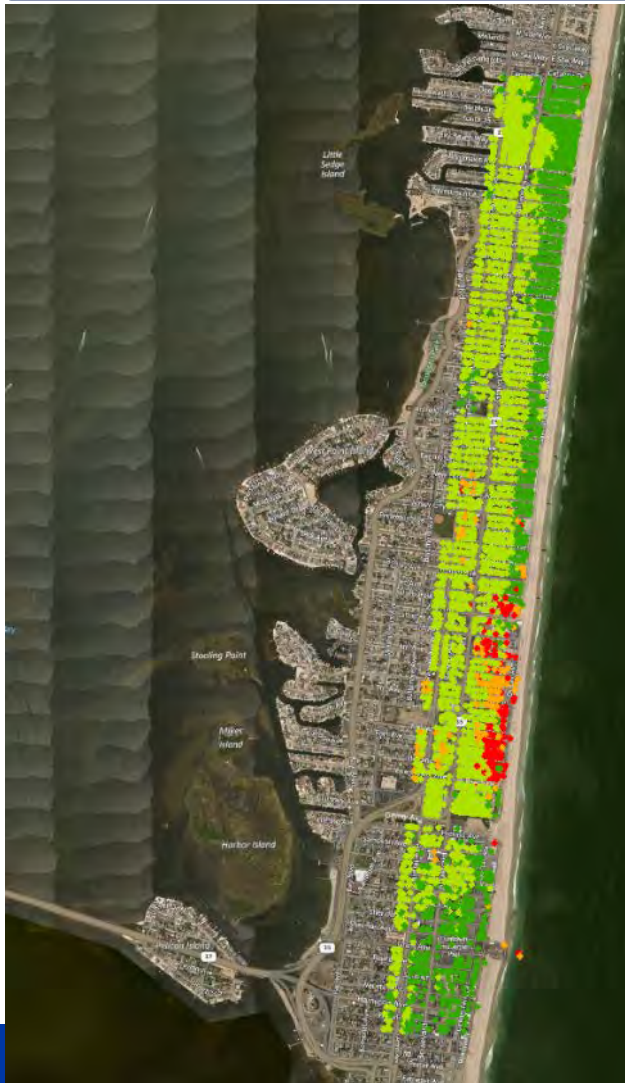
Aboveground Buildings Movement [FEMA DATA]

- ◆ Affected
- ◆ Minor
- ◆ Major
- ◆ Destroyed

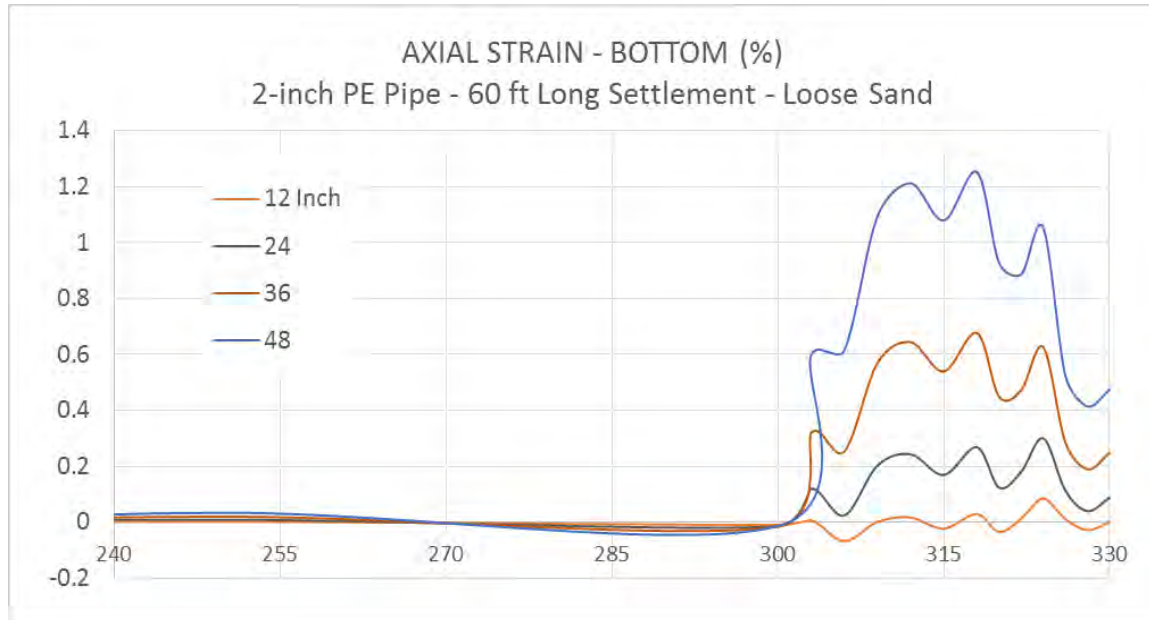
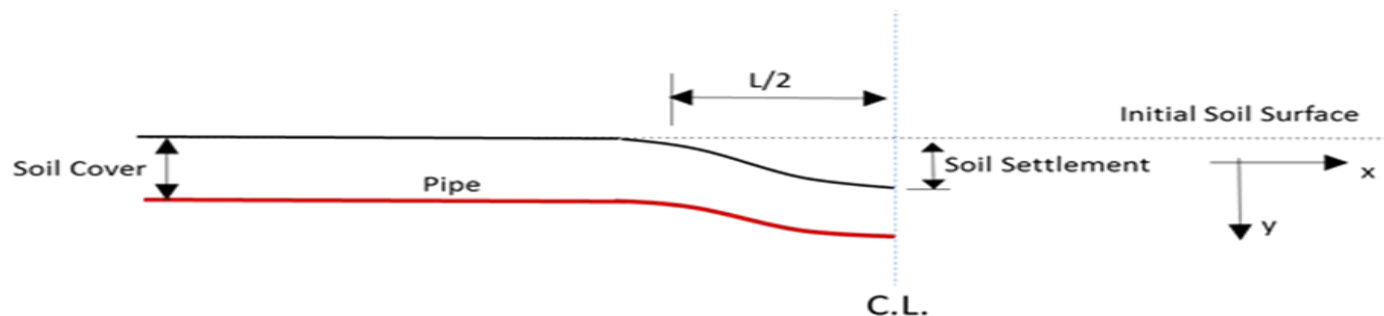
PE-Pipe Deformation
Due to Vertical Soil
Movement

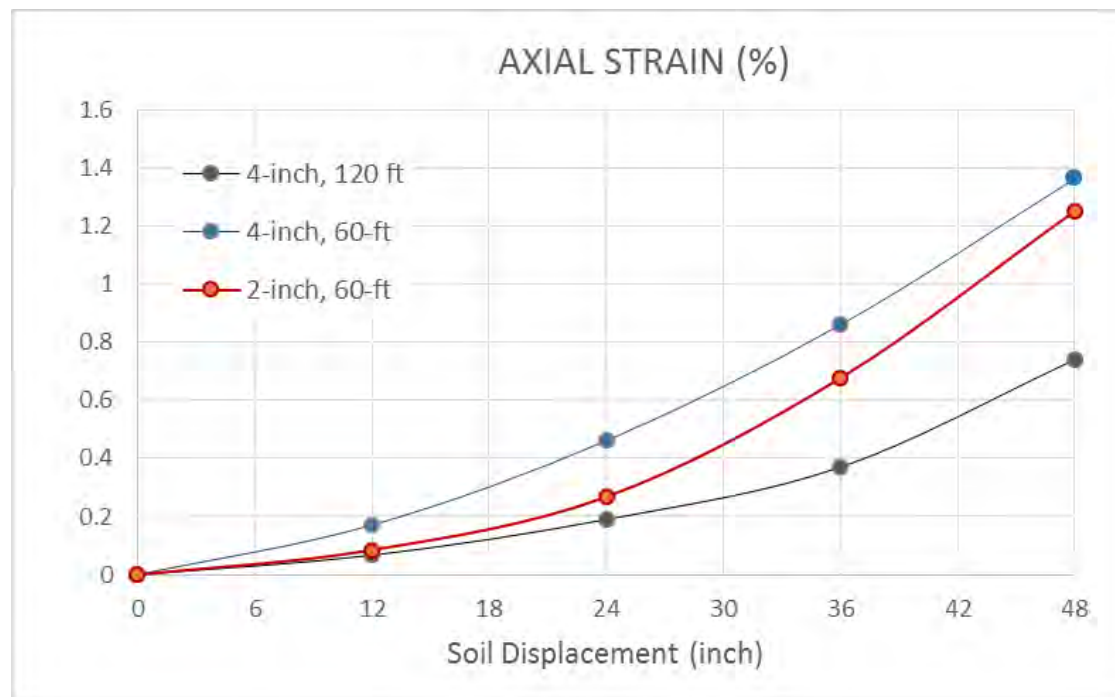
PE-Pipe Deformation Due to Vertical Soil Movement

2 – 4 inch PE Pipe
Loose Sand – Settlement Length 60 -120 ft

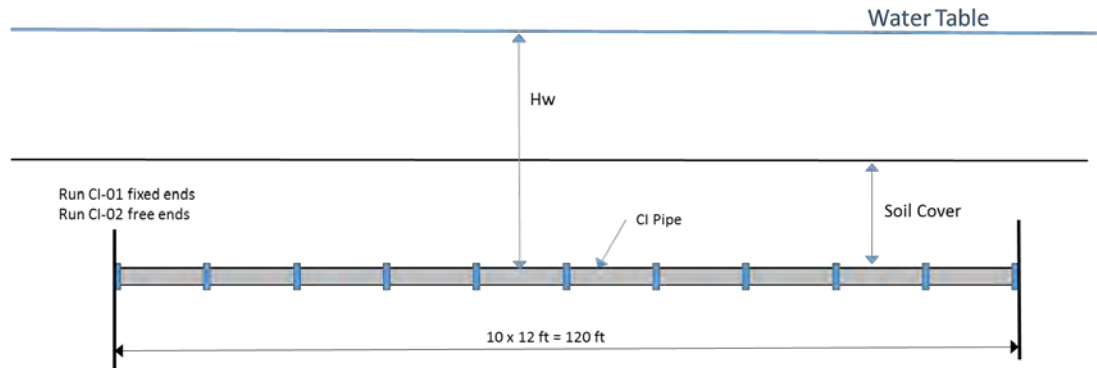
Water Intrusion and Uplift Due to Flooding

- a) In CI pipes:
Water intrusion when:
 $\gamma_w \cdot H_w > \text{Pipe pressure}$

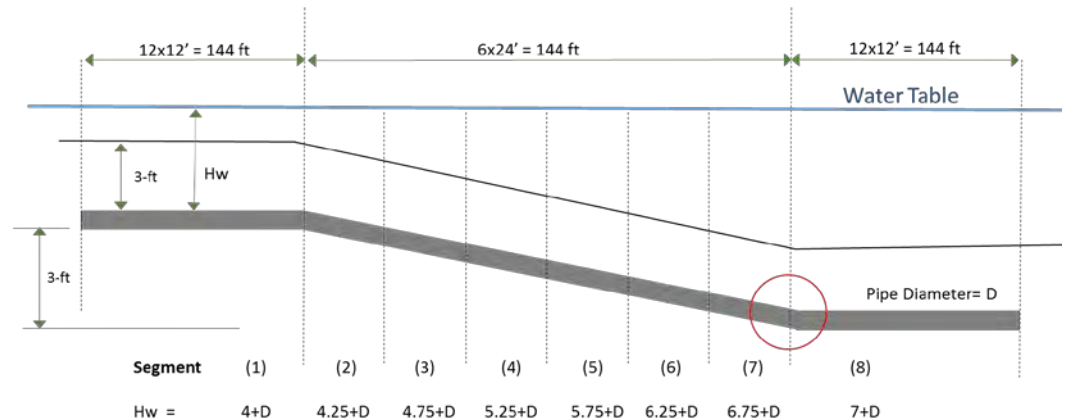
- b) In all pipes:
Uplift load depends on
water table and pipe size.

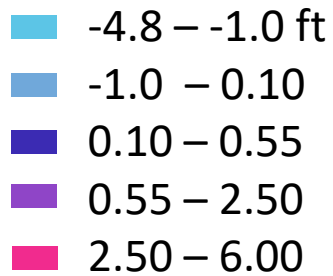
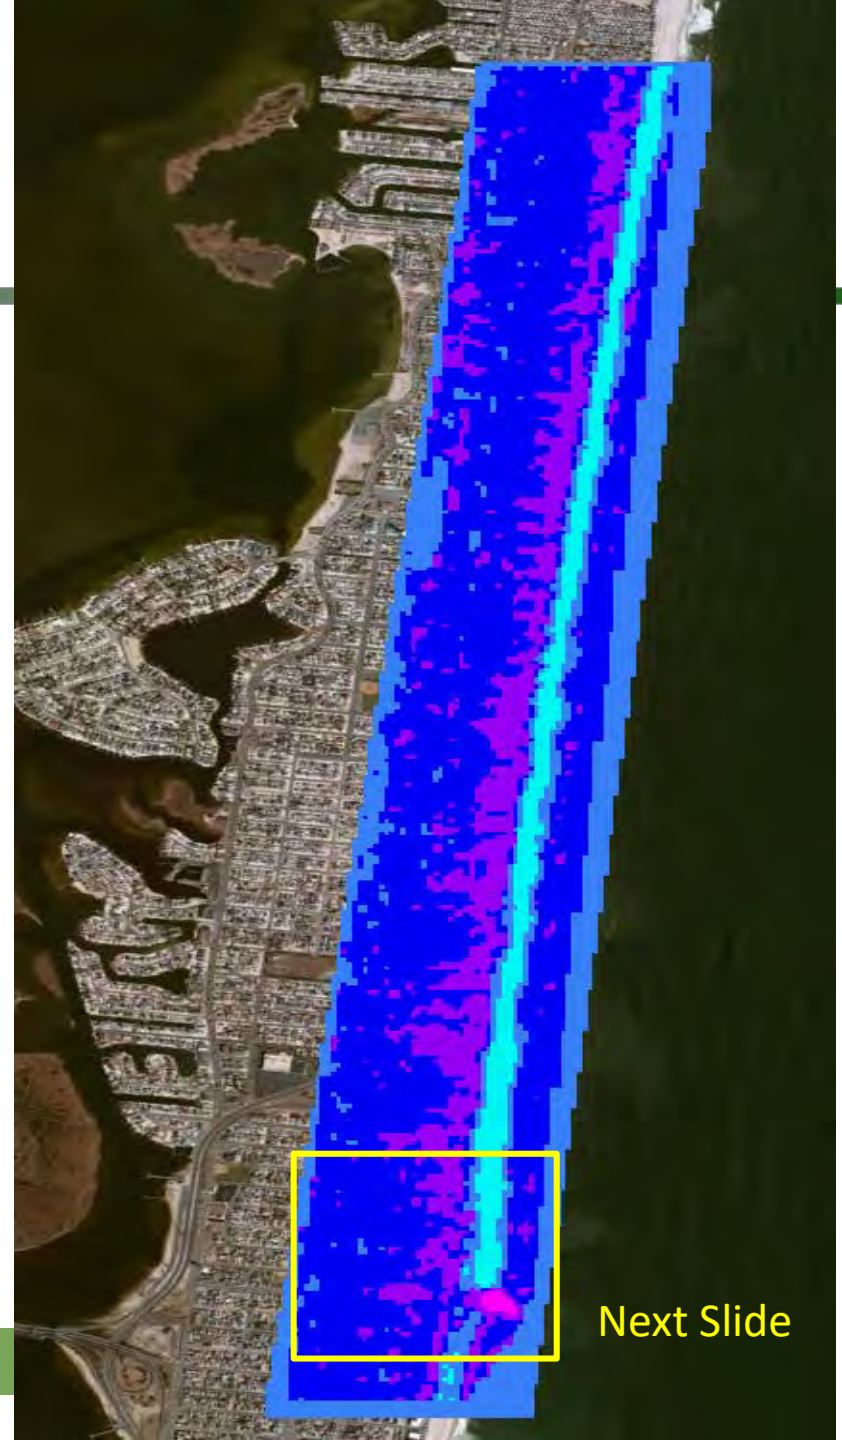
Soil Movement, [LiDAR DATA]

Mean Change of Soil Elevation
[Before & After Sandy]

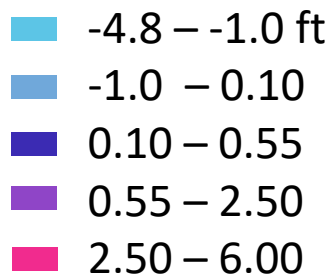
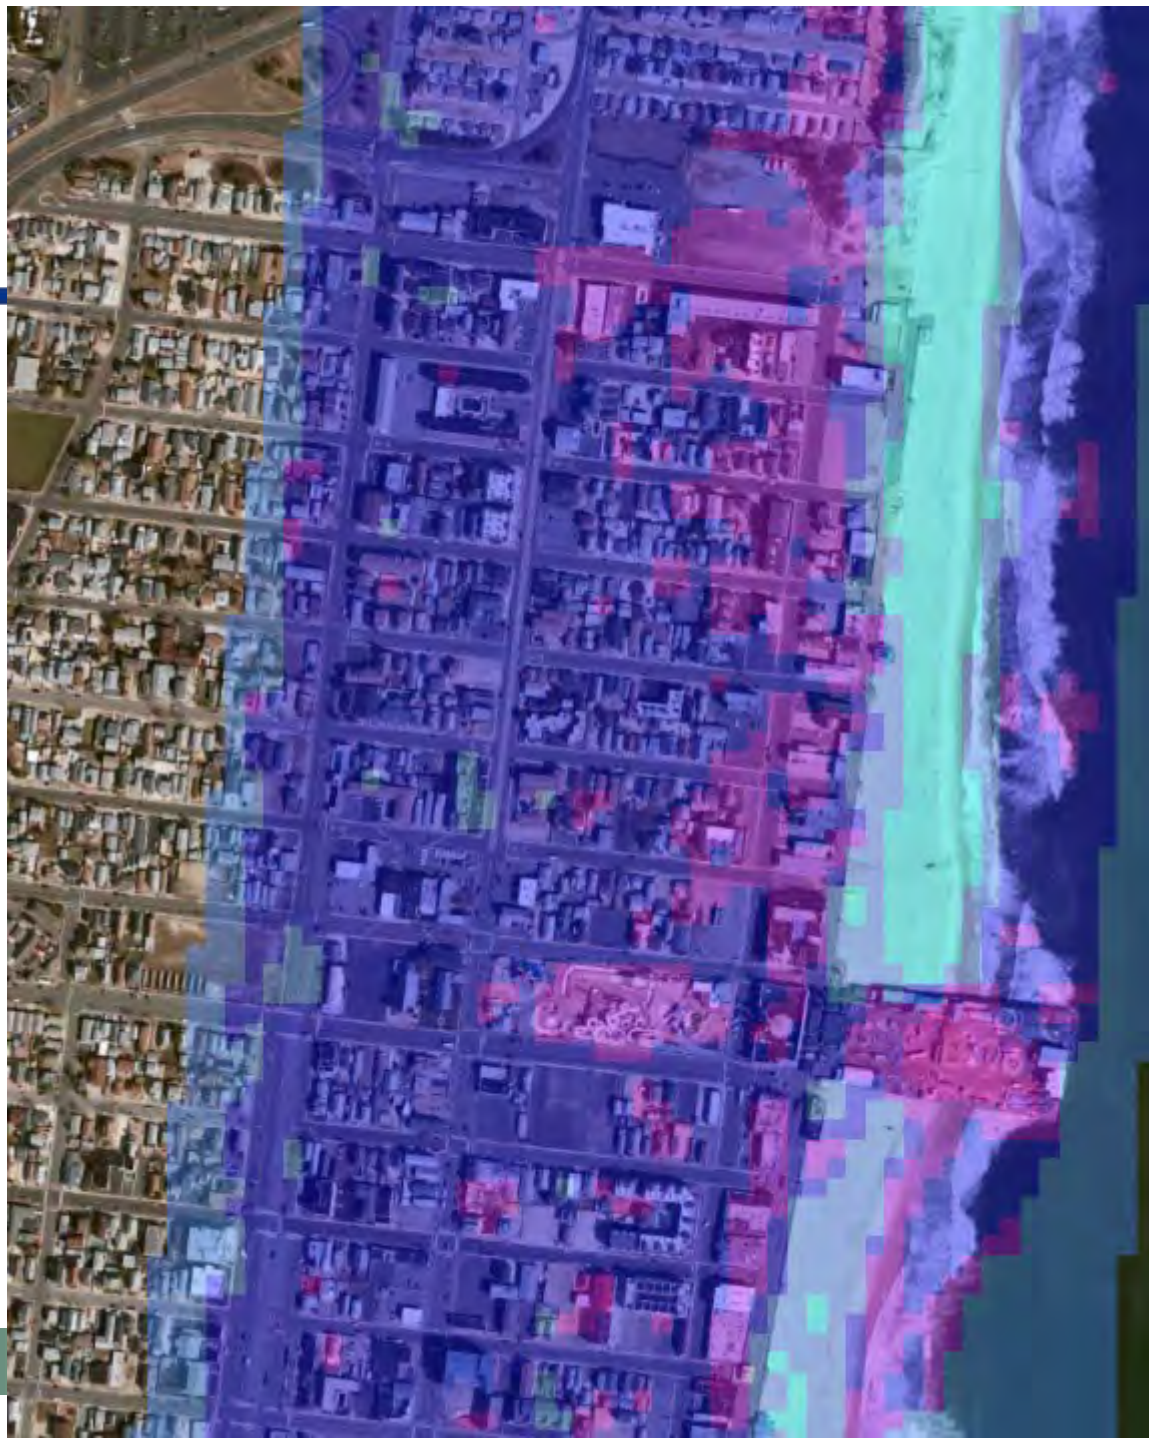
Soil Movement, [LiDAR DATA]

Data Tabulated in 50-ft
Grids, Change of Soil
Elevation

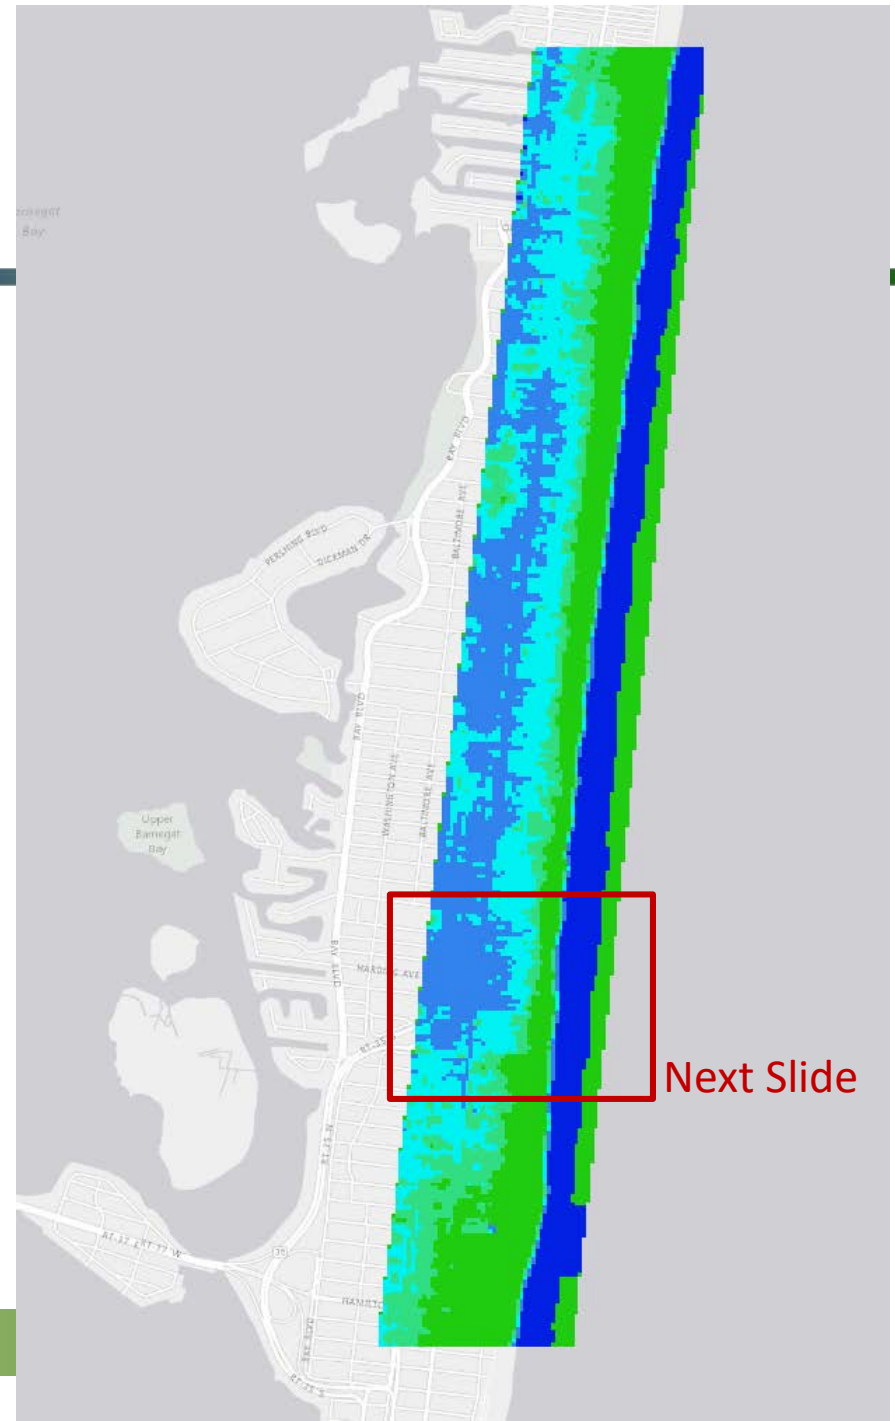
Flooding, [FEMA DATA]

Flood Levels After Sandy

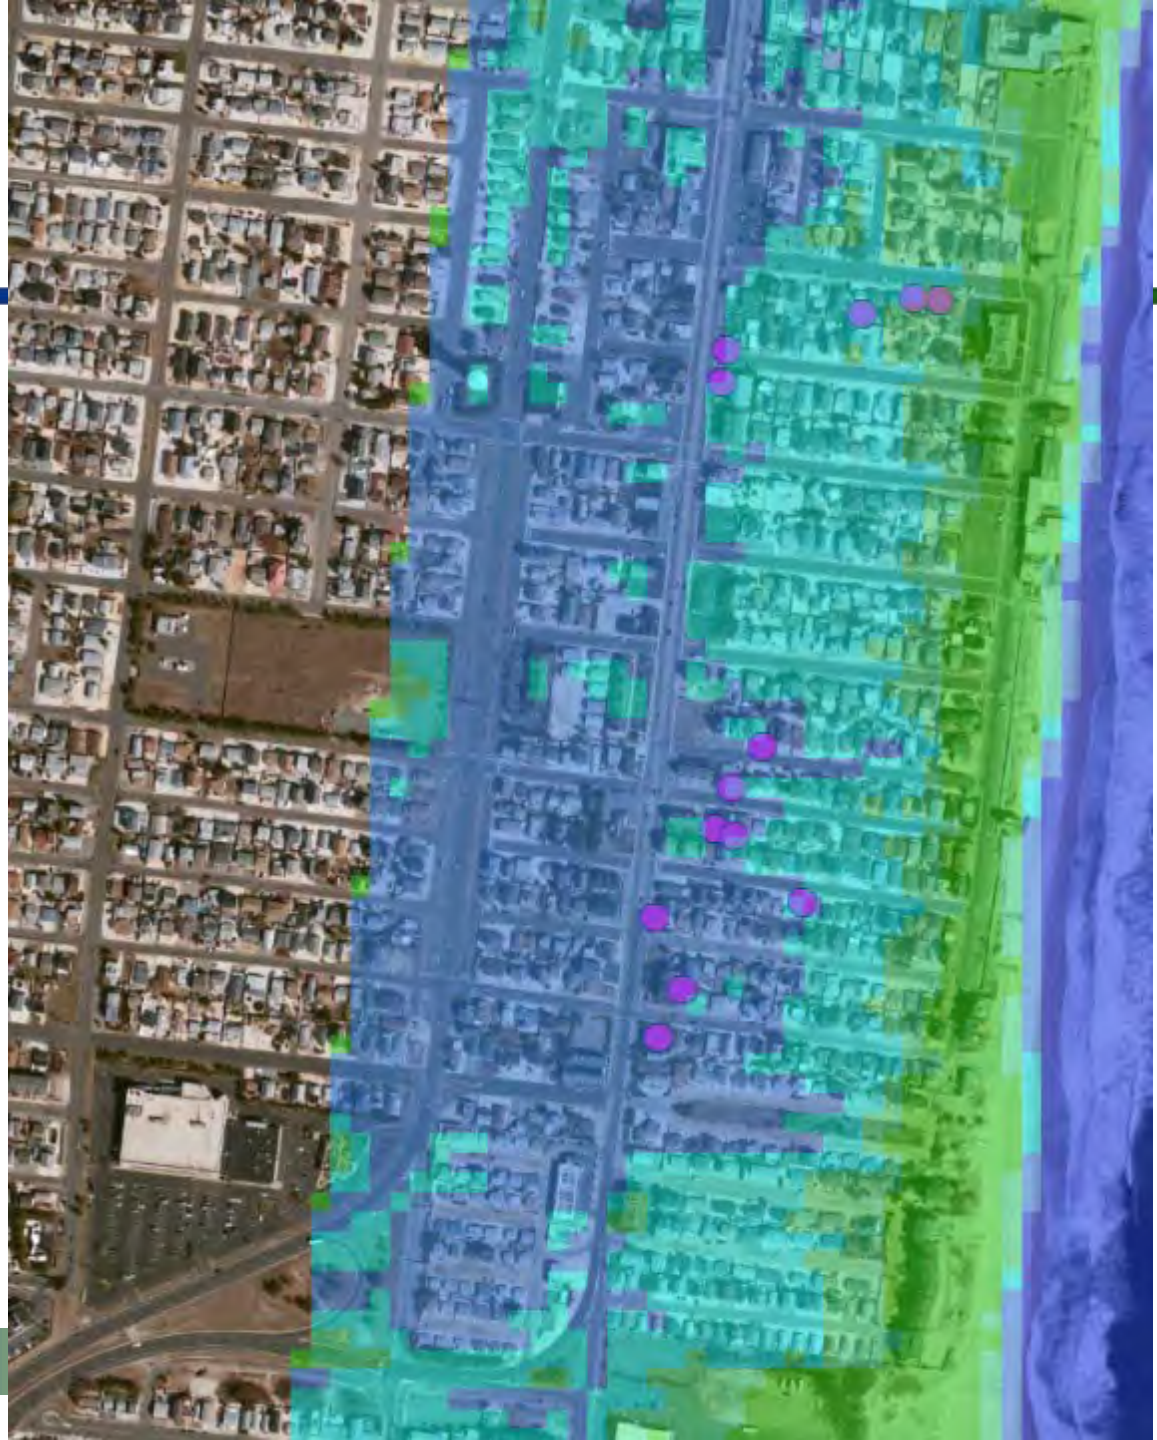
Flood Levels After Sandy

- 0.0 – 1.00 ft
- 1.00 – 2.55
- 2.55 – 3.80
- 3.80 – 6.00

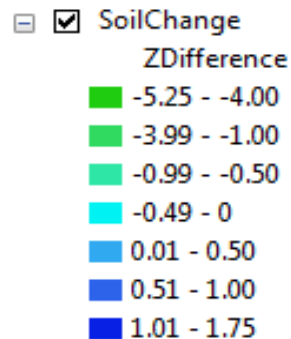
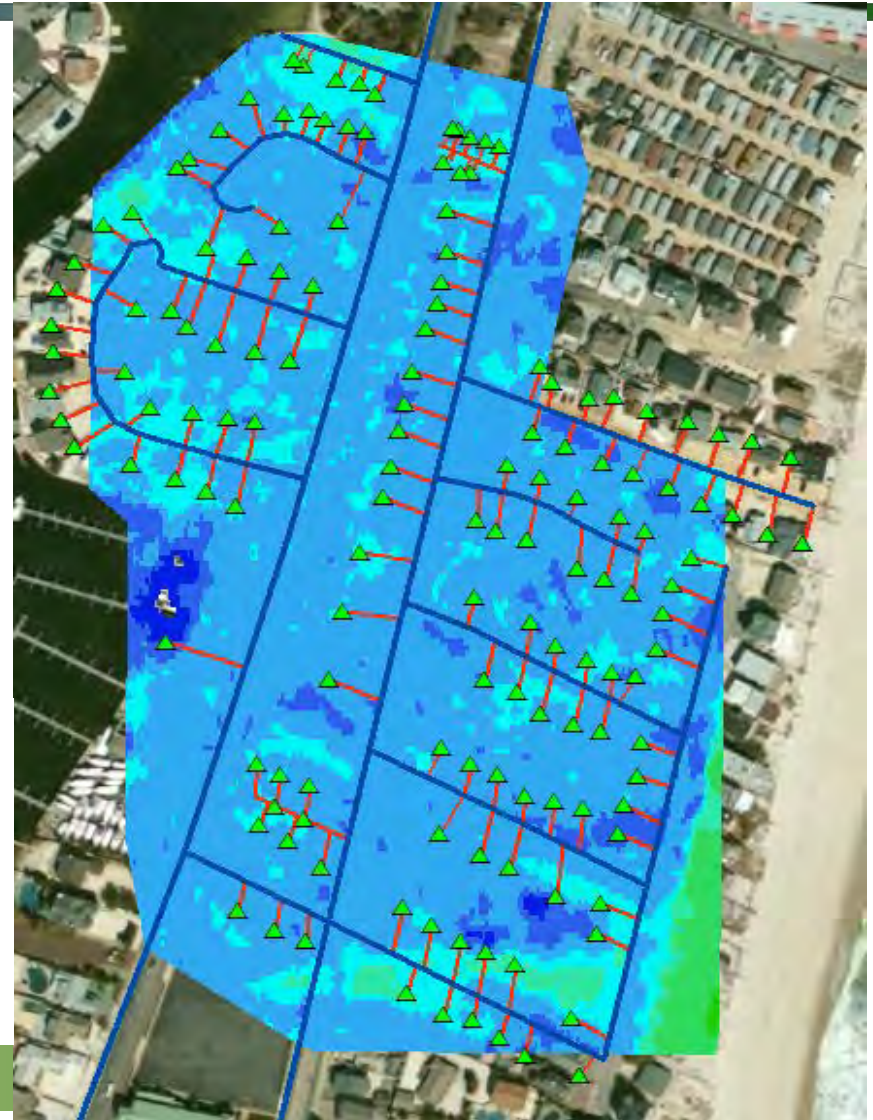
Spatial Changes in soil elevation before and after Sandy.

[Note: Z in this figure is in meters]

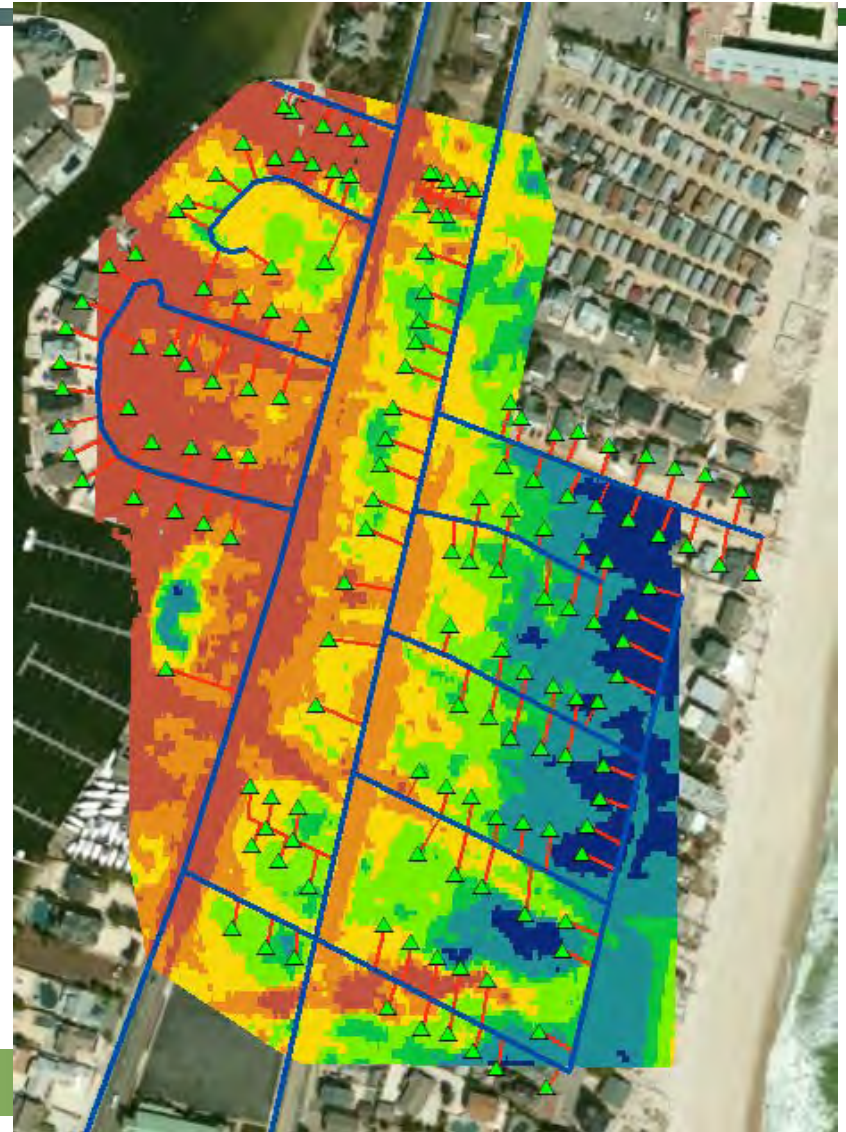
Spatial Changes in water elevation before and after Sandy.

[Note: Z in this figure is in meters]

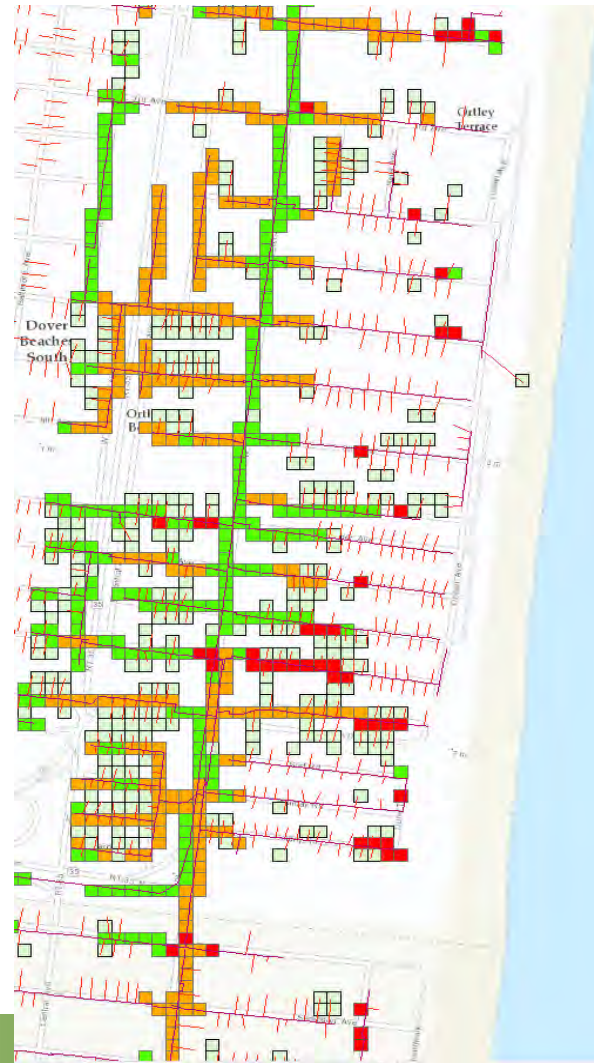
Risk model output in a sample GIS grid:

Damage Likelihood:

- High
- Medium
- Low
